KARIBA - 60 Years Since Inception

A Geological and Geotechnical Review

Tim Broderick

Kariba, November 2015

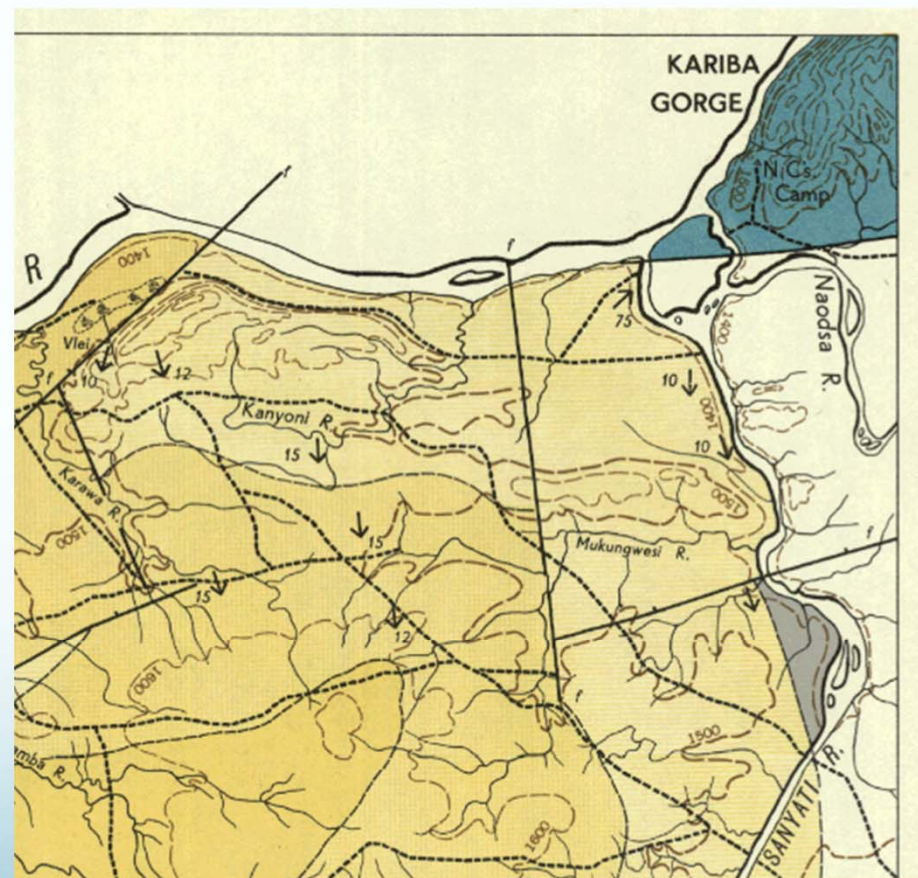
Brassey, 1949

Snapshots from Molyneux's 1910 Sanyati traverse and Brassey's 1949 geological mapping between the Bumi and Sanyati rivers.

Topography was compiled from RAF 1945 aerial photography. Basement to the Karoo sediments remained undifferentiated and correlated to the Lomagundi.

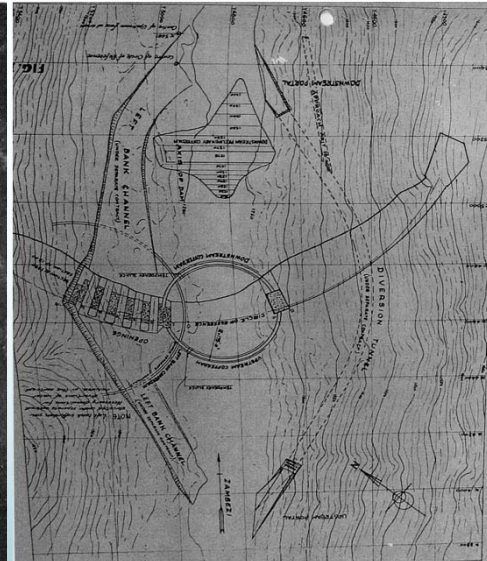
River diversion plan

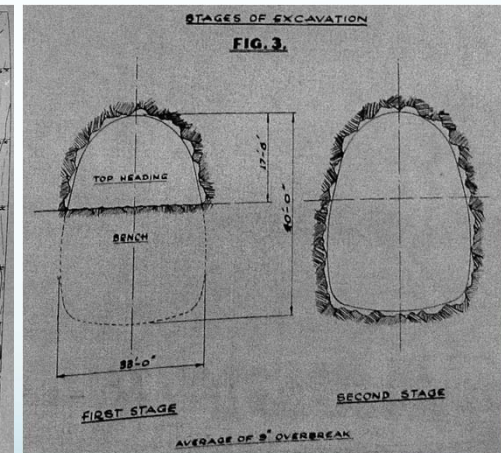
*Section - south-bank
diversion tunnel.*

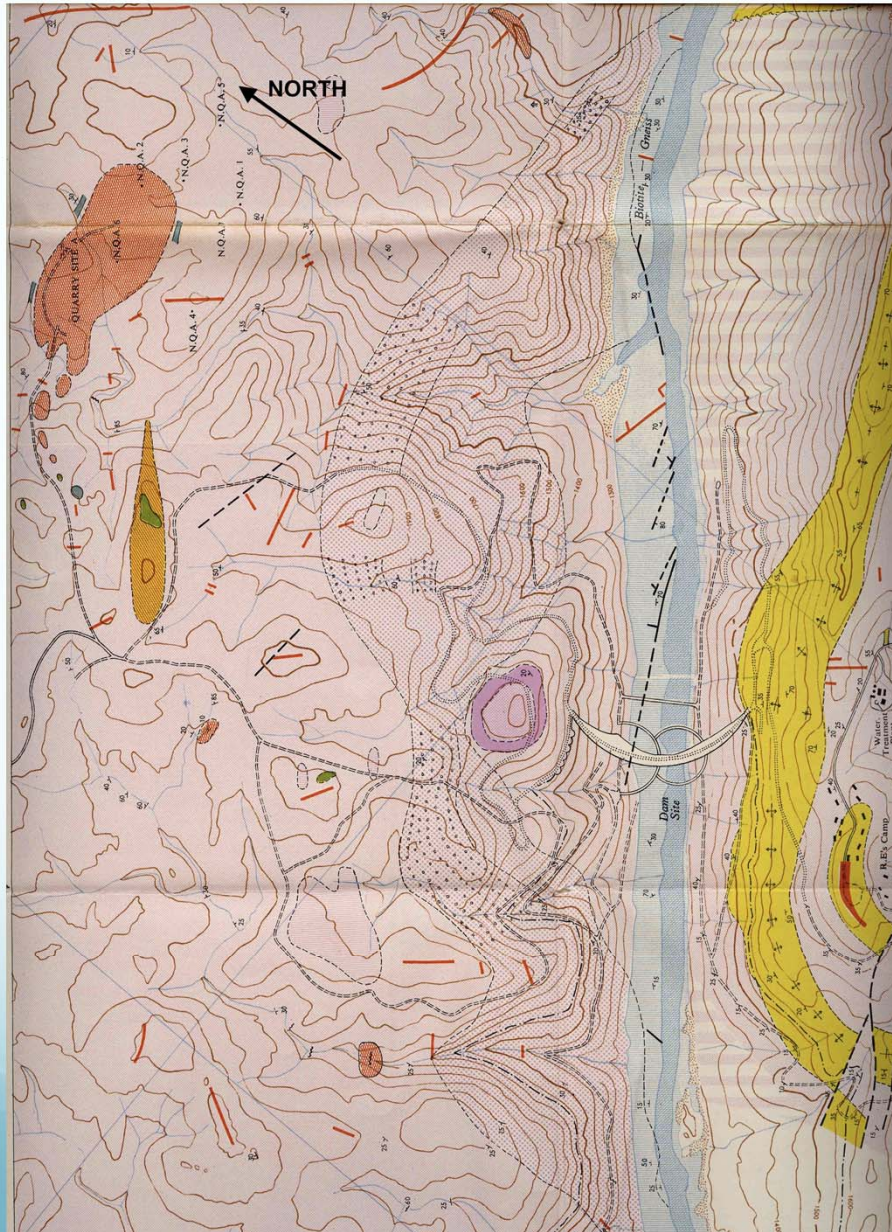
Hitchon, 1958

The Geology across the Kariba Dam Site

Showing the north-bank quarry site in augen gneiss, with borehole locations, and the south or right-bank quartzite over deformed biotite gneiss.

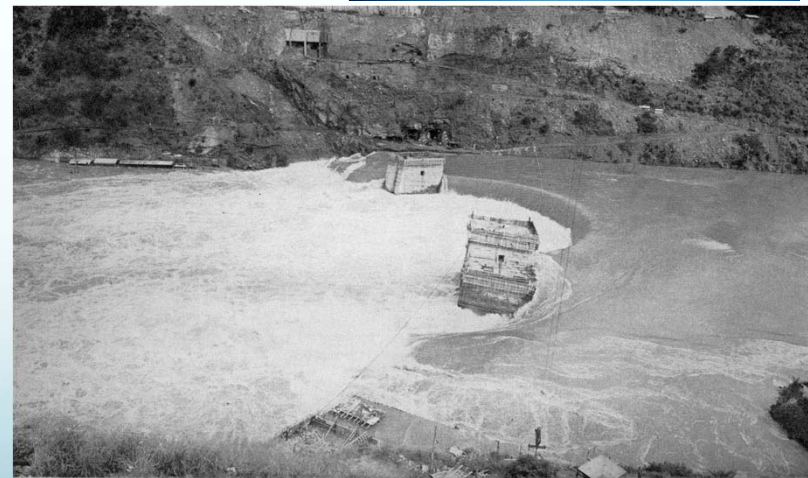
The coffer dam was flooded in March 1957, pumped dry by July and blown on 6th to allow river diversion. The central coffer dam was constructed, but flooded in March 1958 when 10,000 m³/s was coming over the Victoria Falls, coinciding with local floods. The dam was redesigned with six floodgates.

July 1957

March 1958

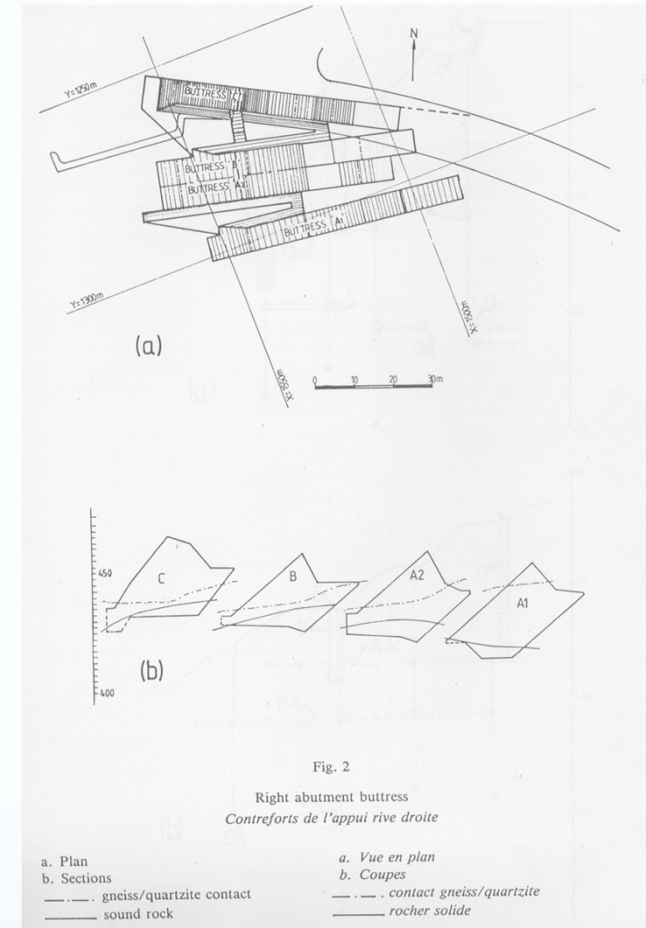
Fig. 2

Right abutment buttress
Contreforts de l'appui rive droite

a. Plan
b. Sections
--- gneiss/quartzite contact
— sound rock
a. Vue en plan
b. Coupes
--- contact gneiss/quartzite
— rocher solide

The decision to proceed with mass replacement of the 'mica seam' with hydraulic concrete buttresses was made in July 1961.

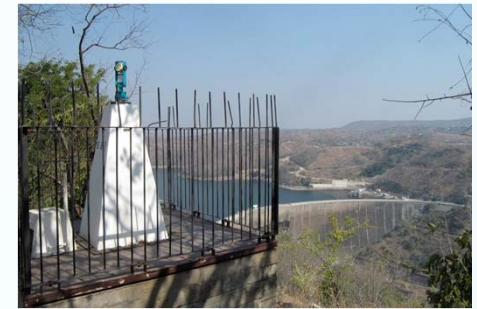
Monitoring and Data Analysis

A comprehensive geodetic monitoring system evolved including:

- ◆ Wall targets and beacons
- ◆ Crest level studs, and joint meters within the dam galleries
- ◆ Strain meters and thermometers in the wall and buttresses
- ◆ Pendulums in shafts and boreholes to monitor the downslope movement

The monitoring system was reviewed and enlarged.

Analysis of the data was developed by Walter Schneider AG of Chur, Switzerland and reported on by Santa Clara and Izzett in 1985

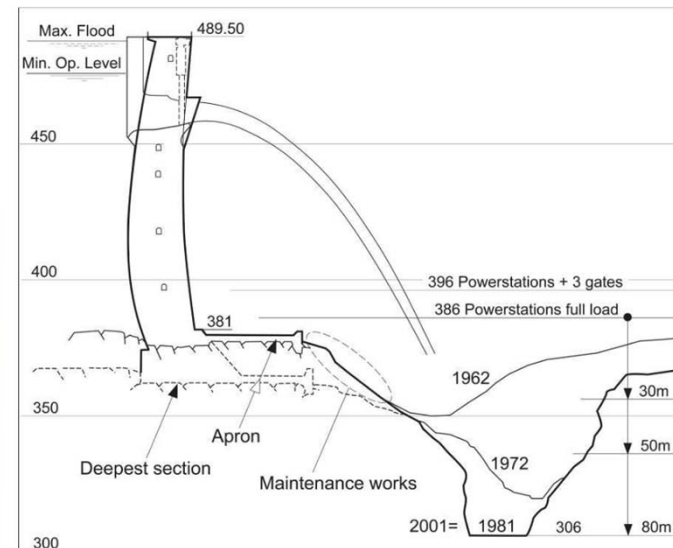
Figure 1: Evolution of the Plunge Pool depth over the years

No significant change since 1981
Stable with respect to the use of non-adjacent gates

By 1981 the pool had reached the predicted depth of 81m when it stabilized, despite reduced spill. About 150,000 m³ of rock had been eroded.

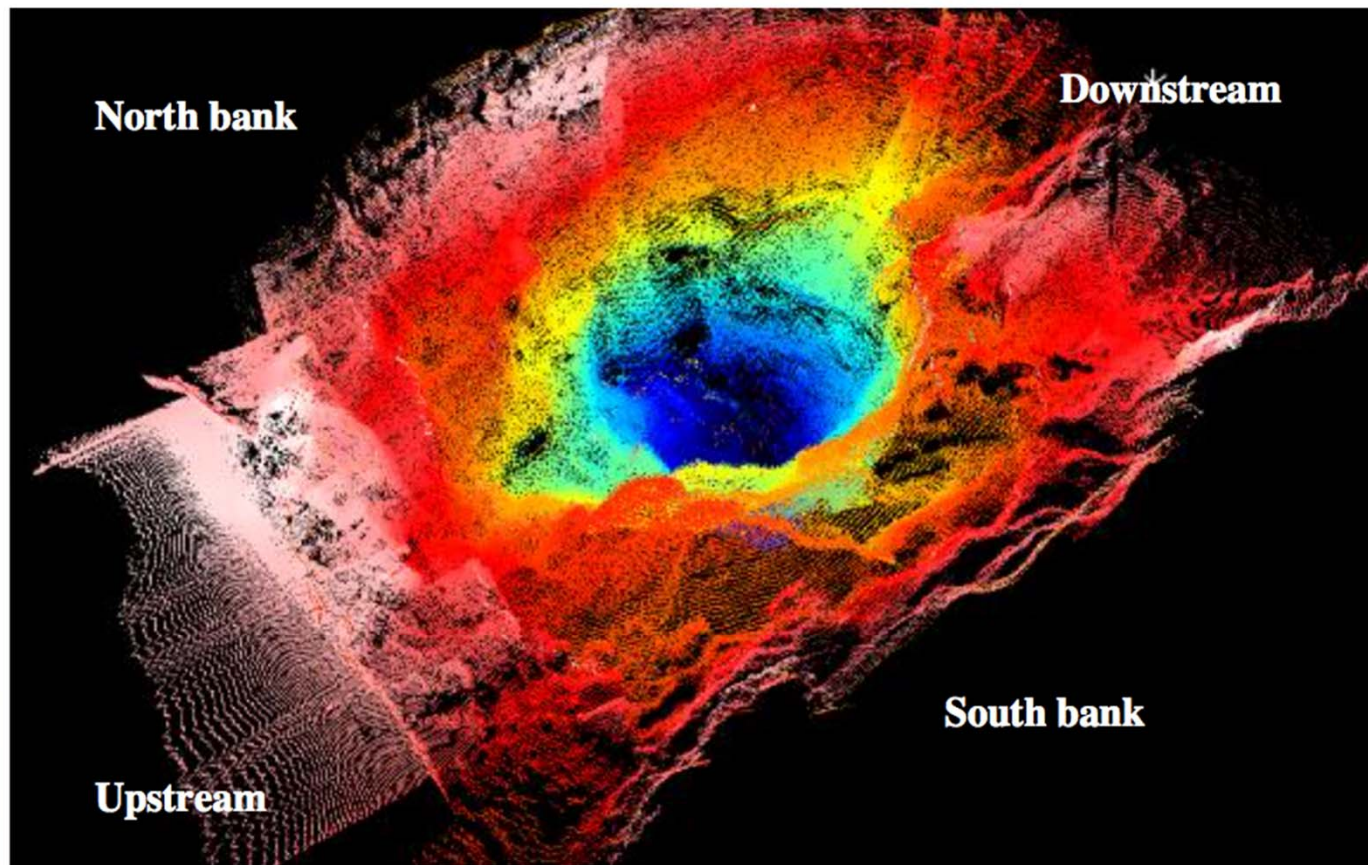
Figure 3 : Modern Bathymetry Survey of March 2011

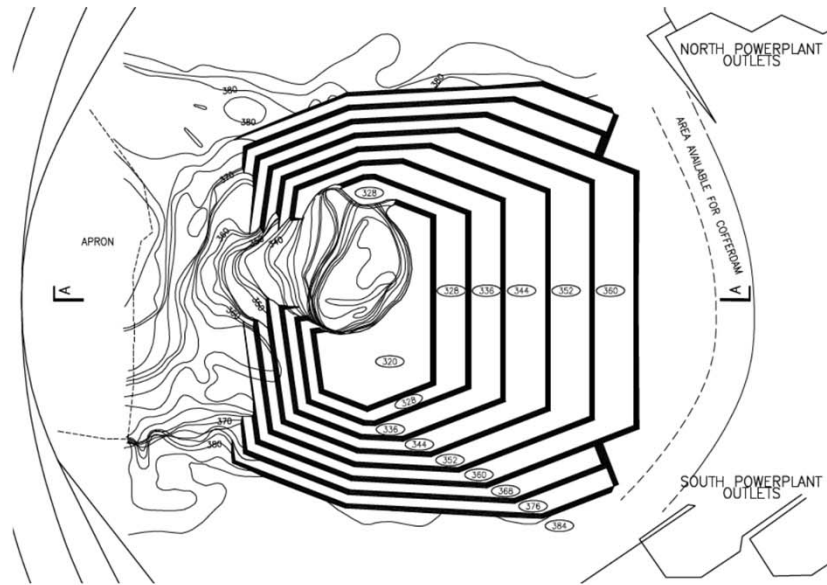
Figure 7: Plan view of the 1st reshaped geometry

Reshaping the plunge pool to minimize scour due to the ‘washing machine’ effect is the most cost-effective

This will take the plunge pool volume to 295,000 m³ with the geometry being satisfactory for any situation of gate opening or power house function (Noret *et al.*, 2012).

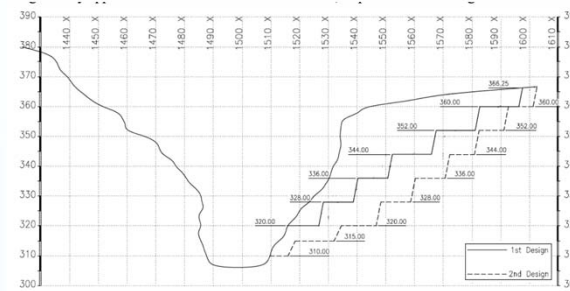
Figure 8: Difference between the 1st and the 2nd reshaped geometries along the dam axis.

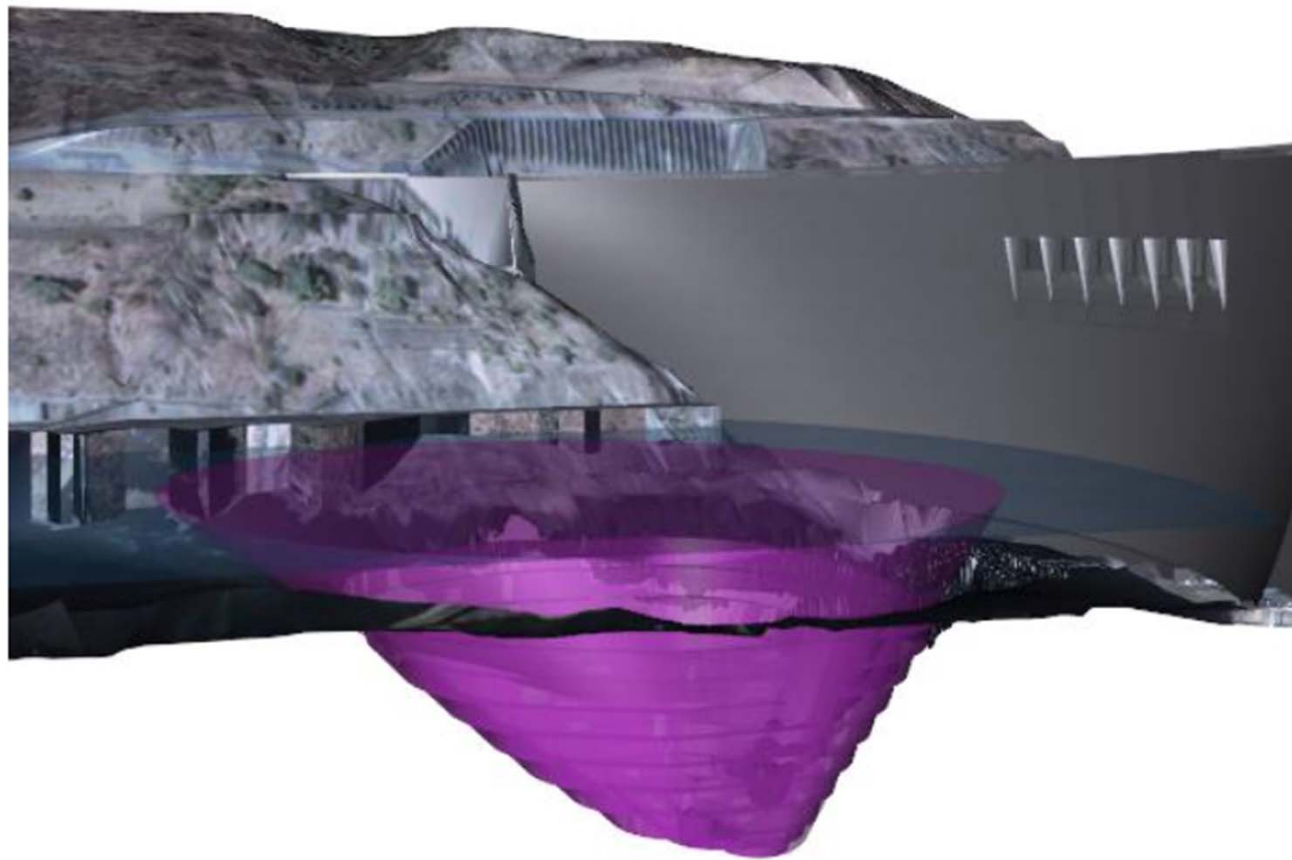
The foreseen model of the plunge pool

Design was aided by means of a hydraulic model established in the Coyne et Bellier laboratory, France.

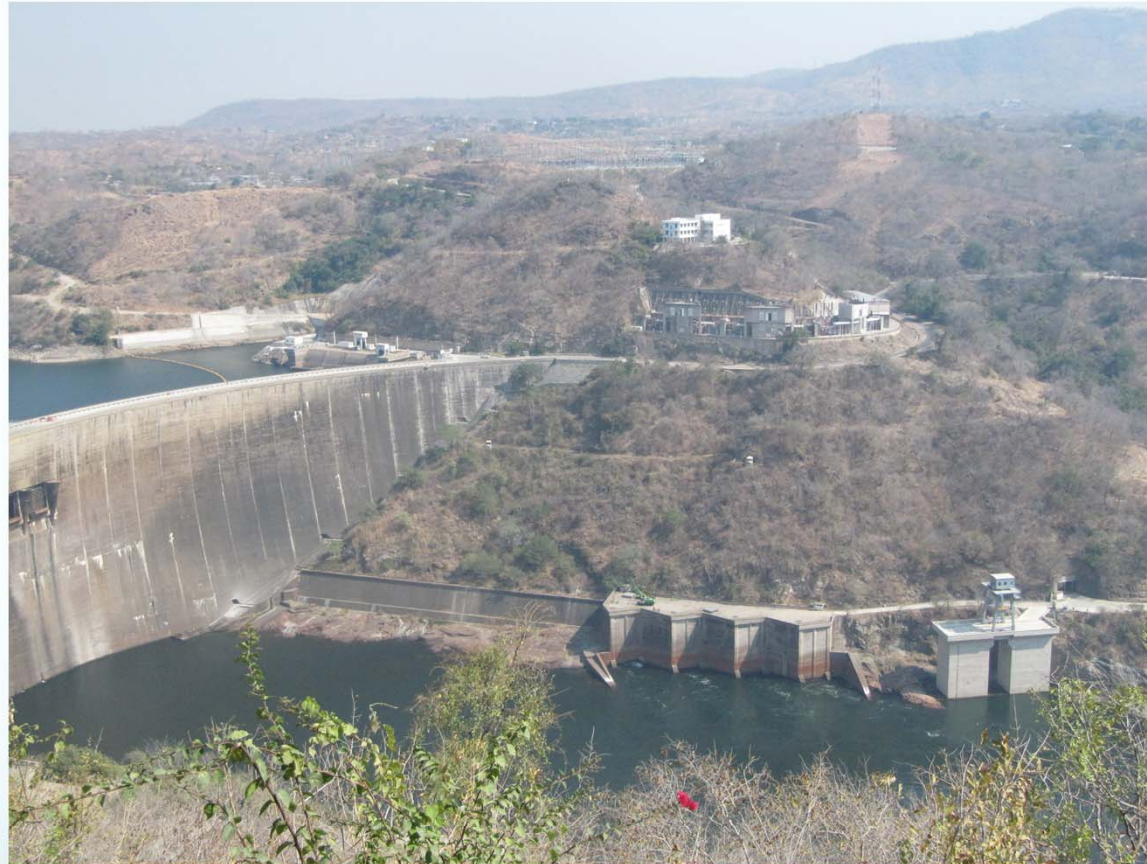
Recently two new 180MW generators have been installed in the north-bank power house, with ancillary intake and tailrace infrastructure.
