GRADE IMPROVEMENT THROUGH MULTI-DISCIPLINARY TEAM SYNERGIES – A CASE STUDY OF UNKI MINE, GREAT DYKE OF ZIMBABWE

**M. HLAMBELO, C. MWATAHWA, AND C. MUSA
ANGLO AMERICAN PLATINUM**

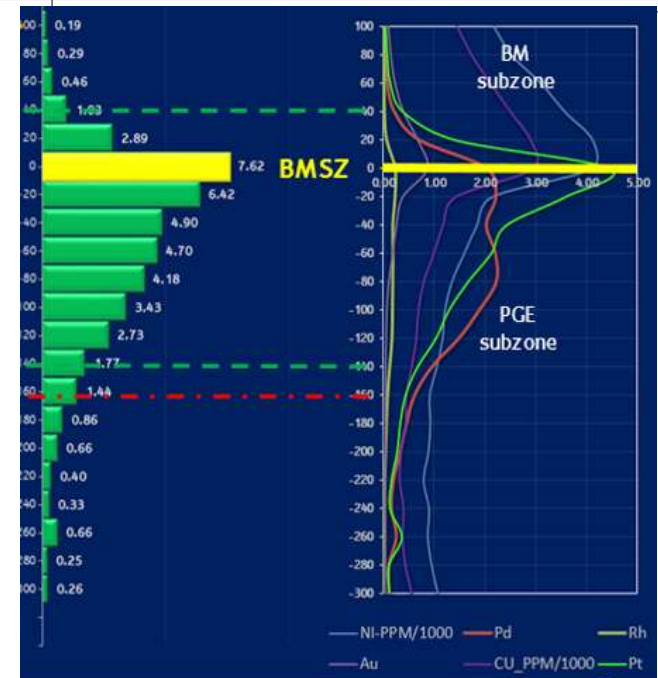
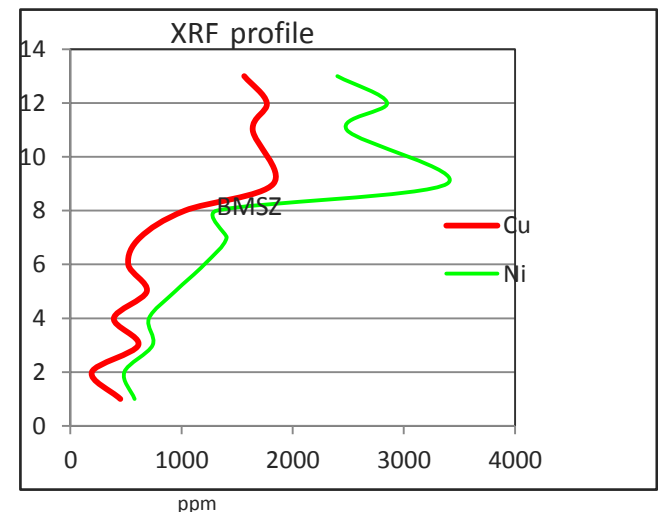
CALIBRATION OF CORRECT REEF SLICE POSITIONING PROCESS

Pt Peak Coincident with BMSZ	75%
Pt Peak within 20cm of BMSZ	20%
Pt Peak outside 20cm	5%

- Visual determination of the position of the Base of Base Metals Subzone (BMSZ) by assessment of sulphides concentration.
- Worst case : Leave Pt Peak in HW - dilution increases from 4 to 22%
- SOR after every 3 blasts to mitigate dilution: Ni and Cu. Added Pt and Pd assays using AAS with TAT of 24hrs.
- ***Pt Pd from AAS, Ni and Cu from XRF.***

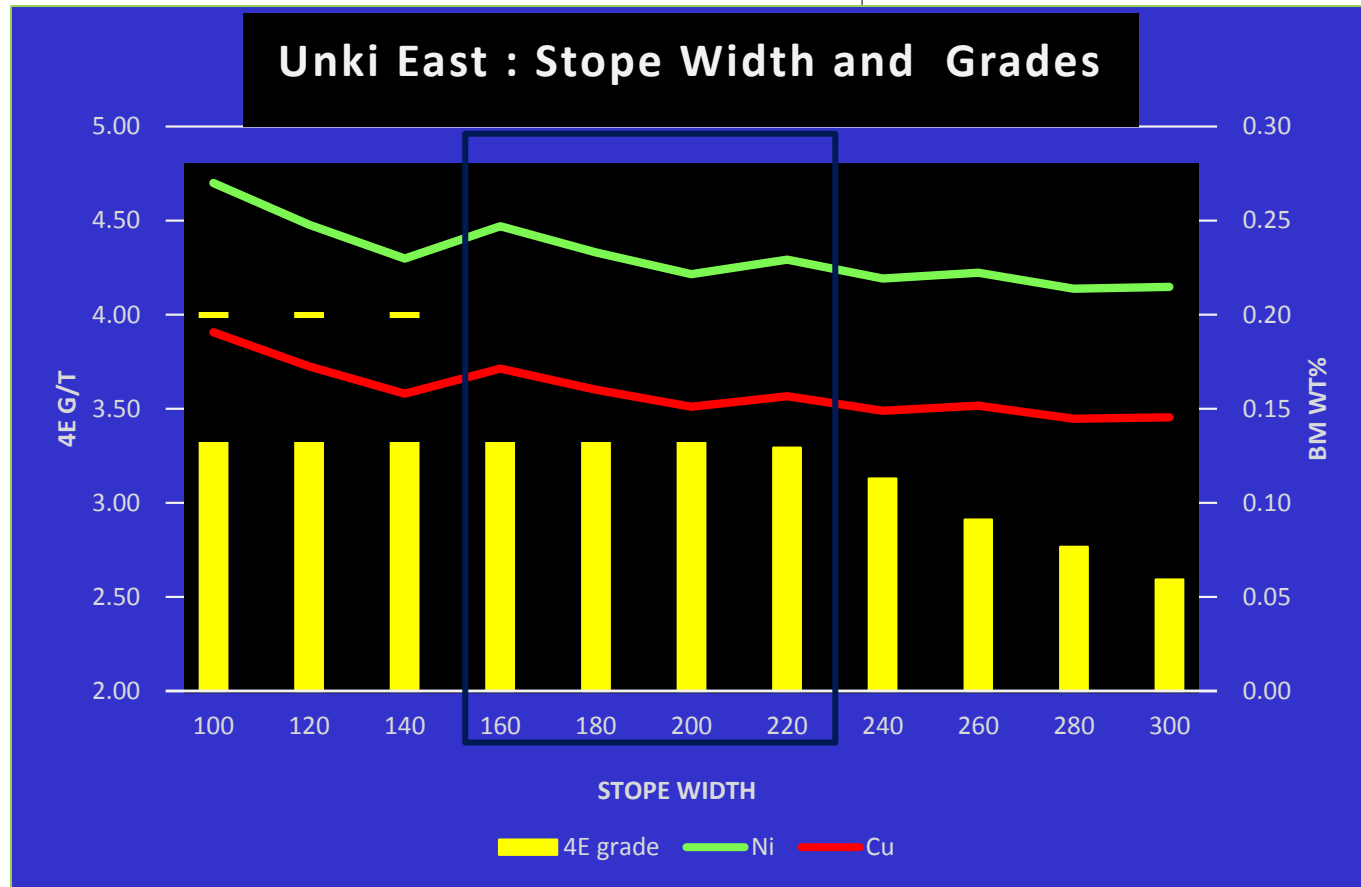
STOPE WIDTH REDUCTION

- 4E grade highly sensitive to broken Stope widths.
- Focus on reducing Stope widths for all teams from an average of 2.19m to below 2.04m

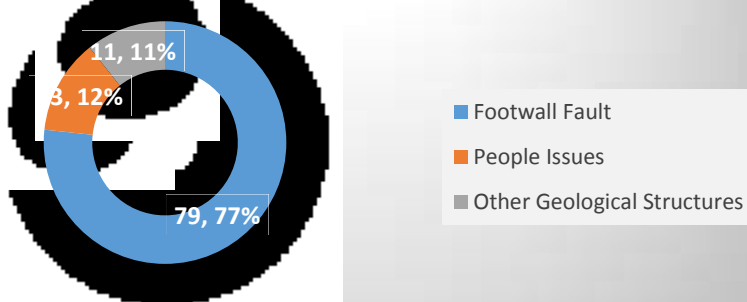
South Section : Levels 1 - 4

- Footwall Fault impact significant in the Upper Levels as well as the South Section.
- Low angle Joints, Domes & mainly E-W trending faults, dykes had significant impact in the North Section : Also contributing to Poor Ground Conditions in this Section.
- People Issues: Poor marking, drill and blast.

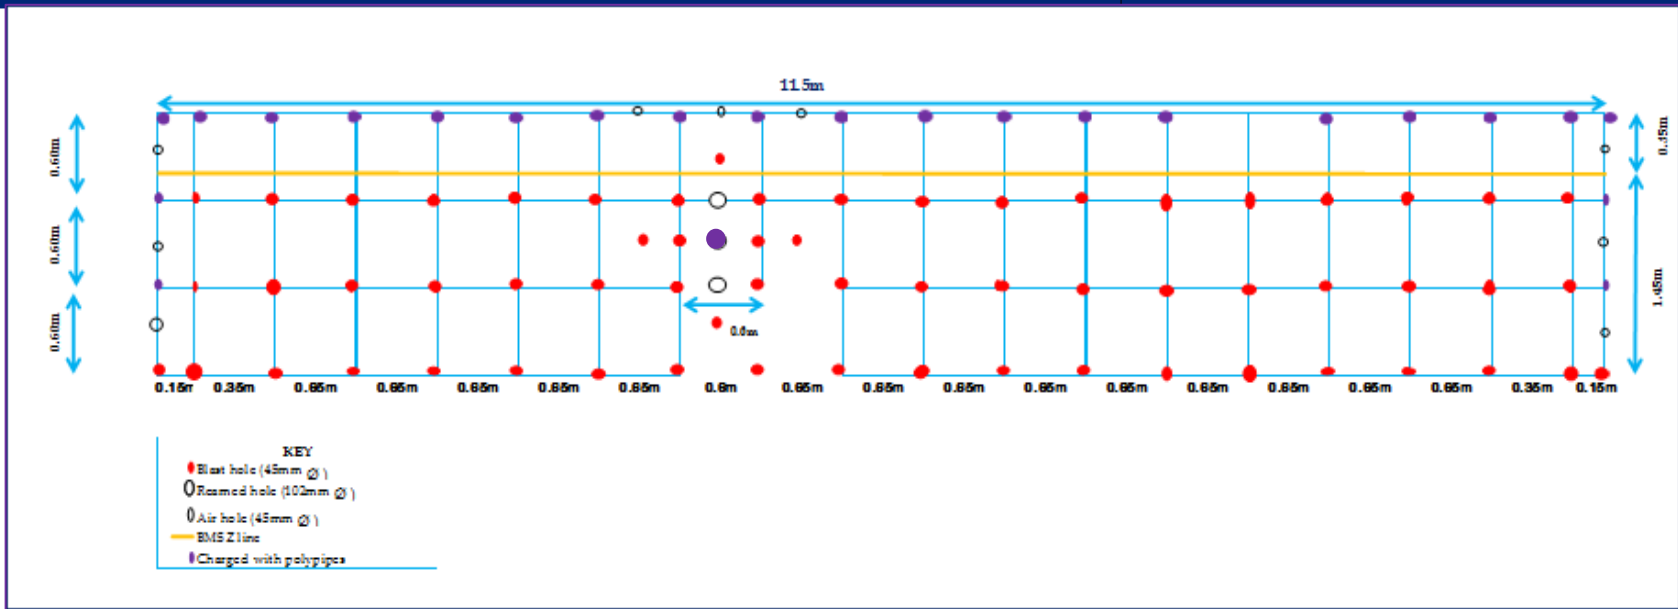
BLAST DESIGN CHANGES

- Practical & well-balanced changes to the blast design by multi-disciplinary team introduced to ensure smooth perimeter control blasting for all types of ground at Unki Mine.
- Introduction of air holes between perimeter holes induce stress line which triggers a pre-splitting of the hangingwall and sidewalls, less damage.
- Reduction of burden and additional line of holes 15cm from sidewalls.
- Use of polypipes in sidewall and hanging wall
- Improvement of drill and blast practice by multi-disciplinary team through continuous monitoring

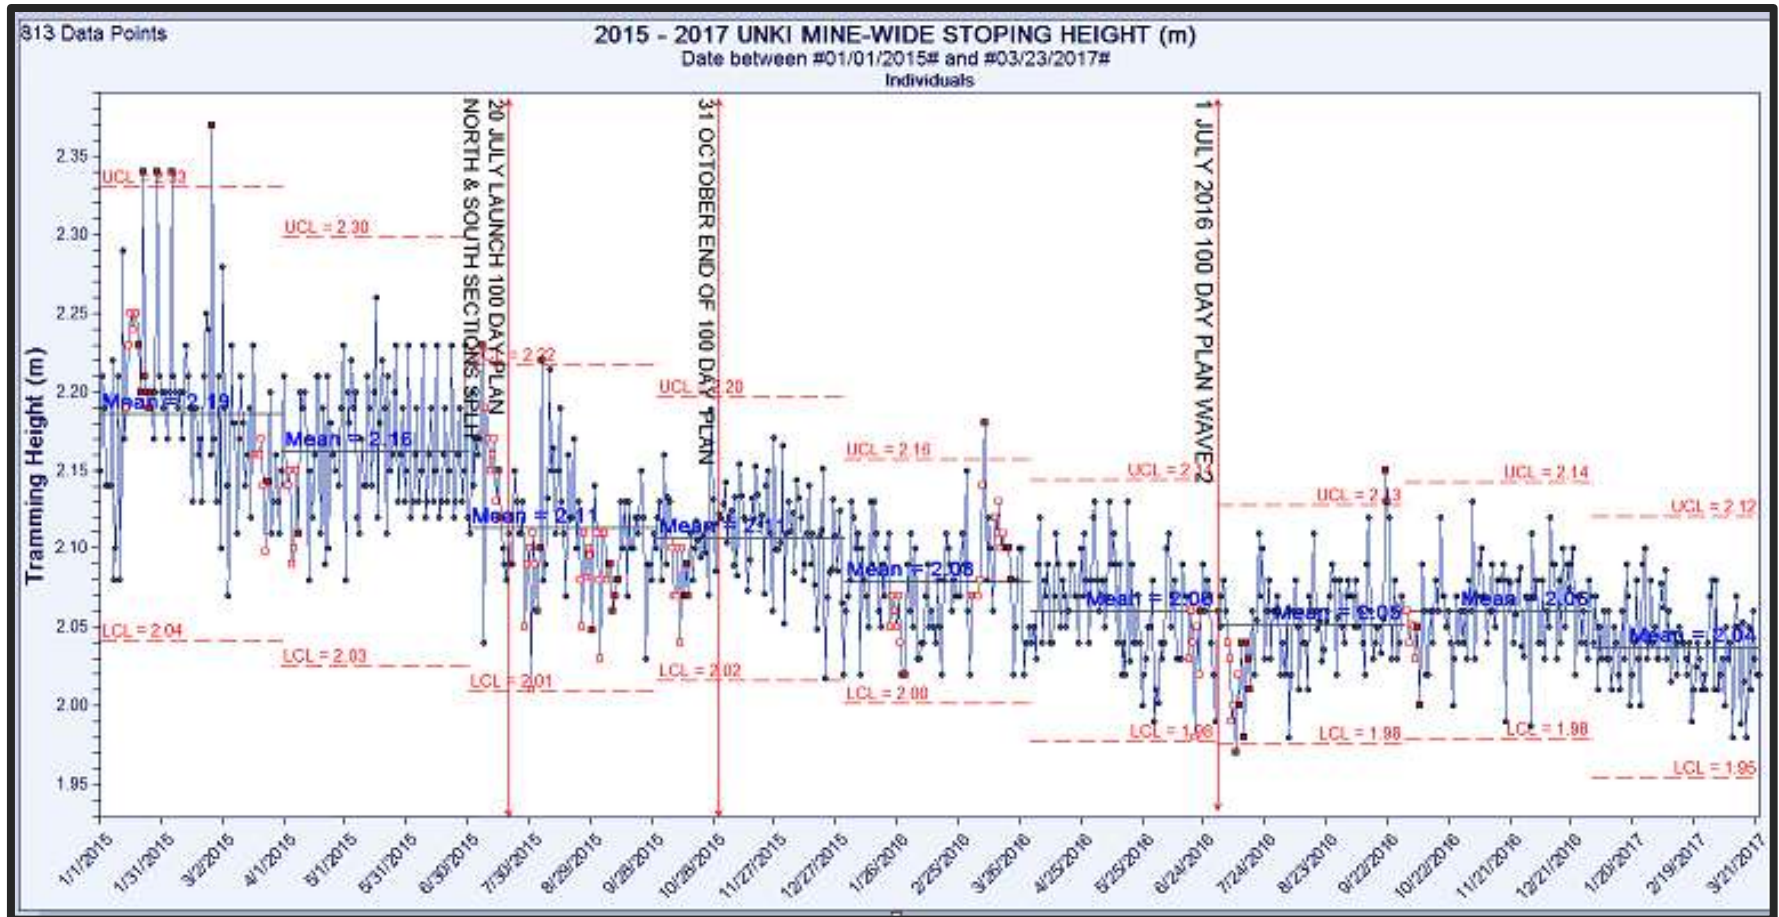
TRACKING STOPE WIDTHS

Daily reviews: SW and SHG with mining teams
Rejuvenation of grade improvement through 100 Day Projects
